MSC-07230

NATIONAL AERONAUTICS AND SPACE ADMINISTRATION

APOLLO 16 MISSION REPORT

MANNED SPACECRAFT CENTER
HOUSTON, TEXAS
AUGUST 1972

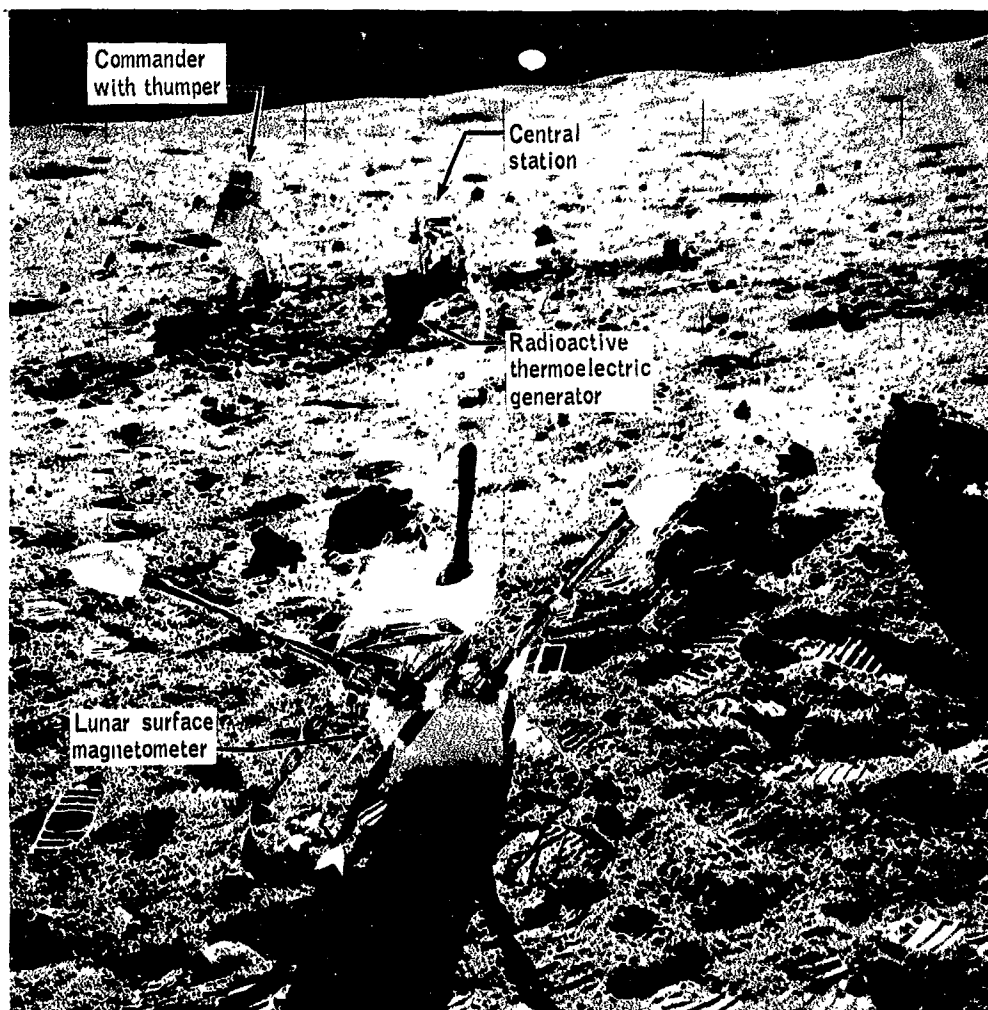
Figure 4-7.- Lunar surface magnetometer experiment and Commander performing active seismic experiment.

Heat flow probe number 1 was inserted into bore hole number 1 to the full depth and both radiation shields were properly emplaced. While the Commander was working near the central station, he became entangled in the

heat flow experiment electronics cable and broke it loose at the connector to the central station. Further deployment was abandoned and the experiment is inoperable. The details of this failure are given in section 14.4.1.

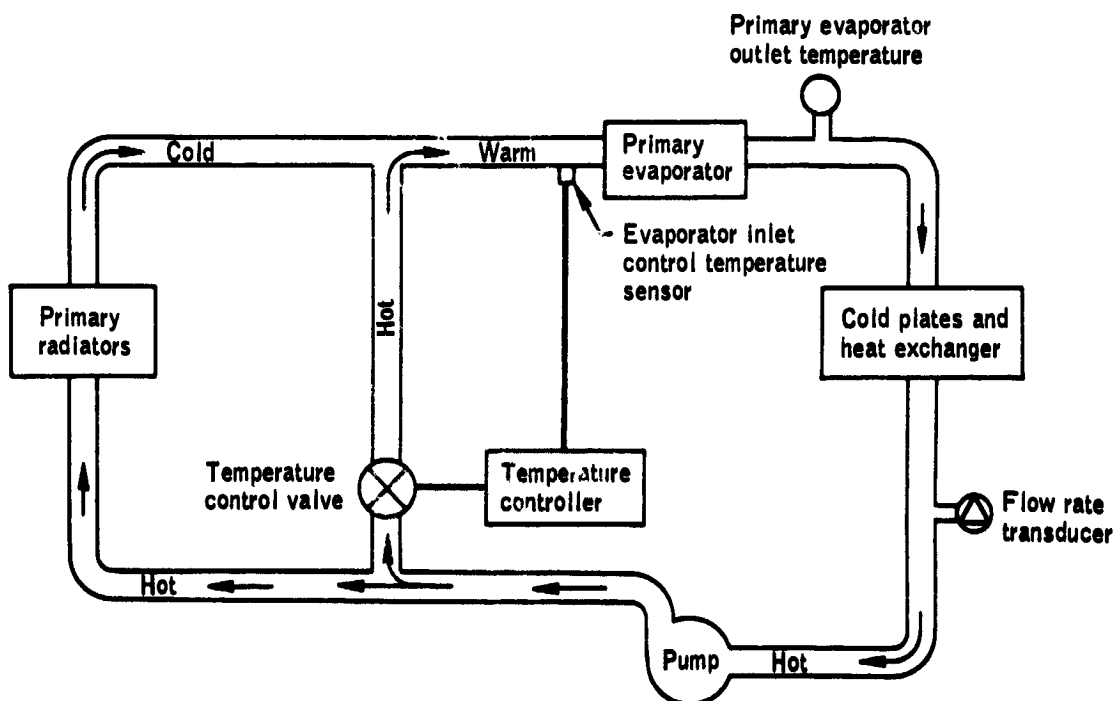
Figure 14-1.- Primary water/glycol coolant loop.

About 3 hours into the mission, the water/glycol temperature control circuit (fig. 14-1) malfunctioned in the automatic mode. The malfunction allowed an excessive amount of hot water/glycol to bypass the radiator causing the mixed water/glycol temperature to exceed the upper control

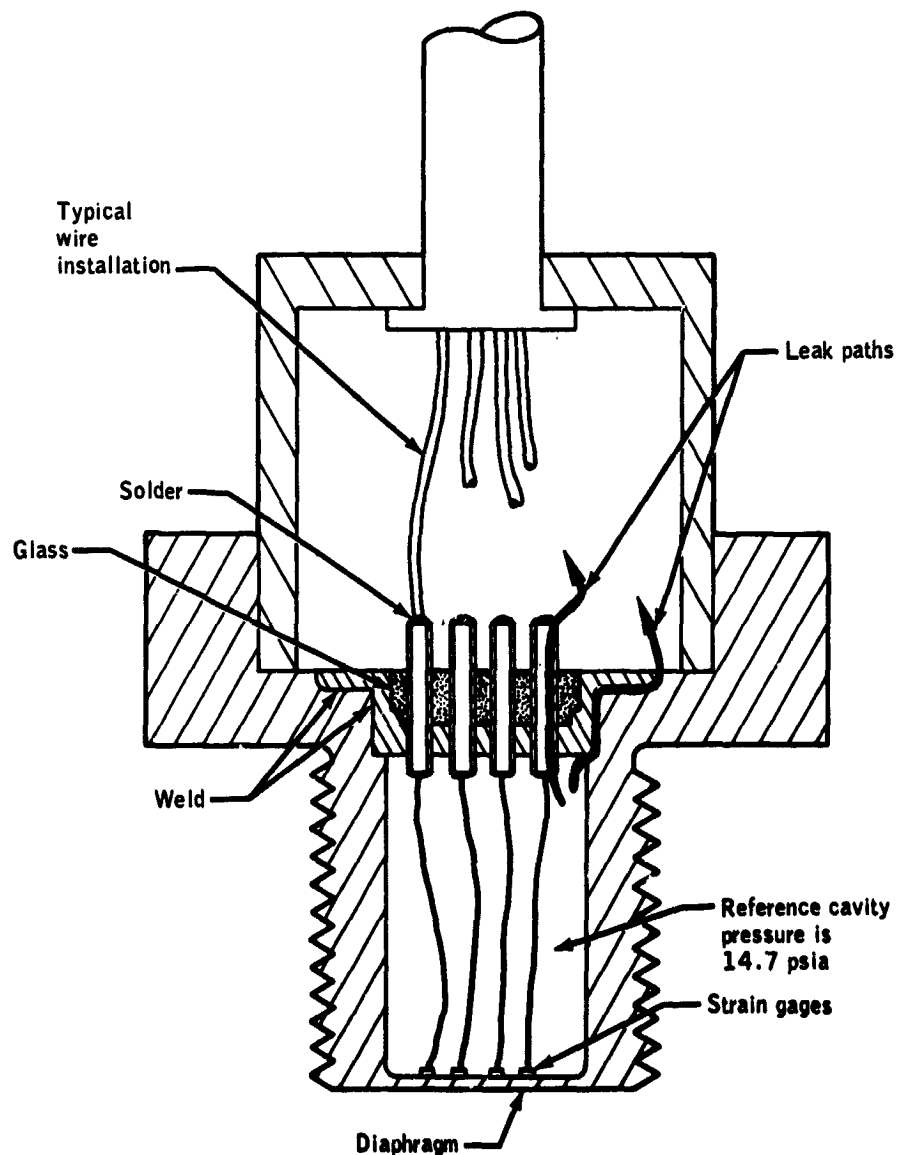
Figure 14-3.- Service propulsion system pressure transducer failure.

Previous experience with this type of transducer showed that the reference cavity can leak through the feed-through tubes in the header and at

the header-to-case weld (fig. 14-3). During altitude chamber tests for Apollo 16 and during the Apollo 12 mission, a similar transducer showed the same type of failure. The Apollo 16 transducer (replaced after the altitude chamber tests) had not had a vacuum check since 1965 to verify that the reference cavity was leak tight. The altitude chamber test is adequate to verify the integrity of this type of pressure transducer.

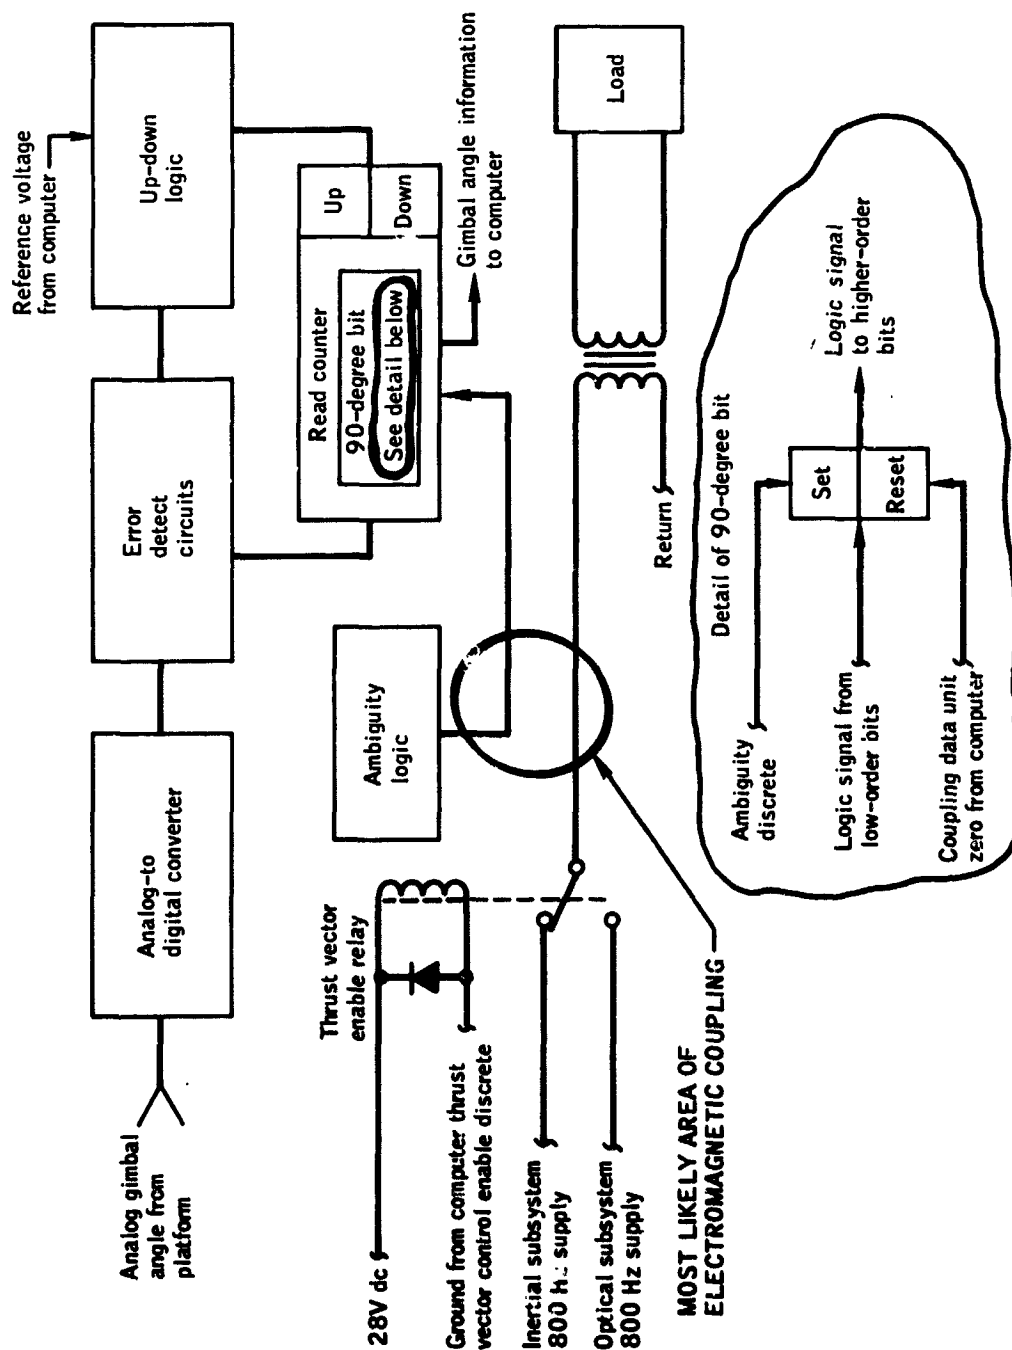
Figure 14-4.- Coupling data unit functional diagram.

Figure 14-4 is a simplified representation of the pertinent circuits in the middle gimbal angle coupling data unit. The purpose of the read counter is to store, in digital form, the platform gimbal angle. If the gimbal angle changes, the analog signal is no longer the same as the digital signal from the read counter and the resulting error signal causes a pulse train to be generated. The pulse train increments or decrements the read counter until it matches the analog gimbal angle. The read counter is a series of flip-flop logic circuits whose only inputs are a pulse train and timing pulses. The 90-degree bit is unique, however, because it can also be set by an ambiguity discrete. The purpose of the ambiguity discrete is to prevent the platform from going to an ambiguous position when the inertial measurement unit is turned on.

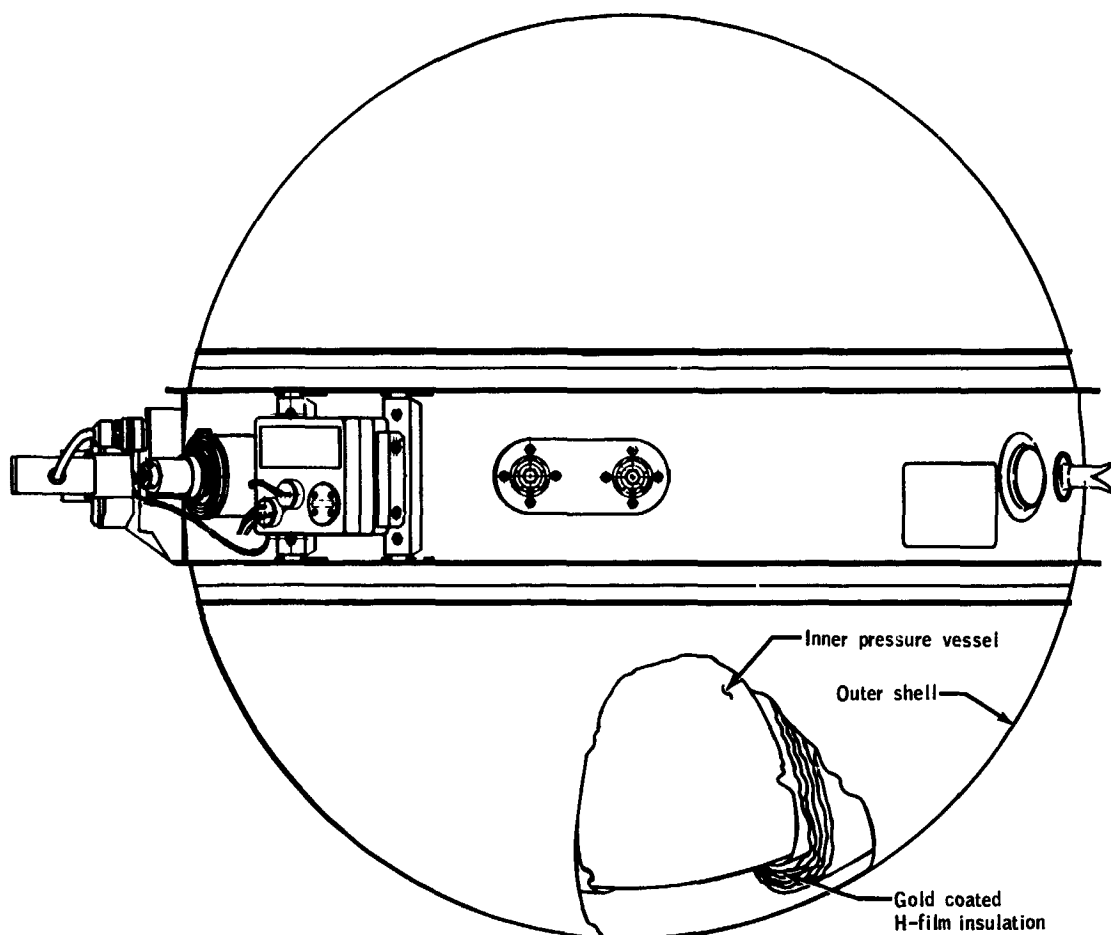
Figure 14-7.- Hydrogen tank.

- a. If thermal insulation layers rubbed together during the launch phase vibration, the condition could have caused the release of previously entrapped or absorbed gas molecules into the annulus (hereafter referred to as "insulation scrubbing").
- b. A hydrogen leak from the pressure vessel into the annulus.
- c. An ambient air leak into the annulus during launch.

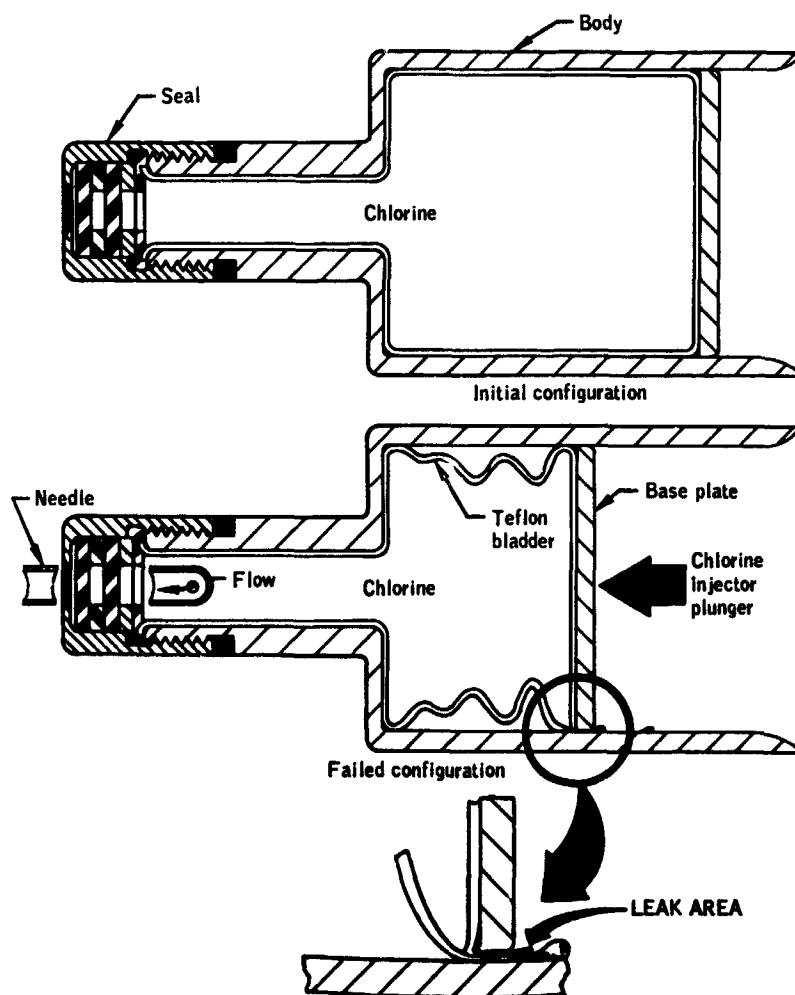
Figure 14-9.- Chlorine ampule failure.

Upon further examination by the crew, the chlorine ampule appeared to be broken (leaking) and the inner bladder was visible after having been extruded past the base plate. Inner bladder extrusion has been observed before but has not been associated with leaks. Figure 14-9 shows typically how the Teflon bladder can be forced past the injector base plate. The body sidewall is not sufficiently rigid to prevent the bladder from extruding around the base plate and being creased, which would be conducive to leaks. Subsequent chlorine injections were satisfactory. The specific ampule which caused the problem was later jettisoned with the lunar module and was not available for postflight inspection.

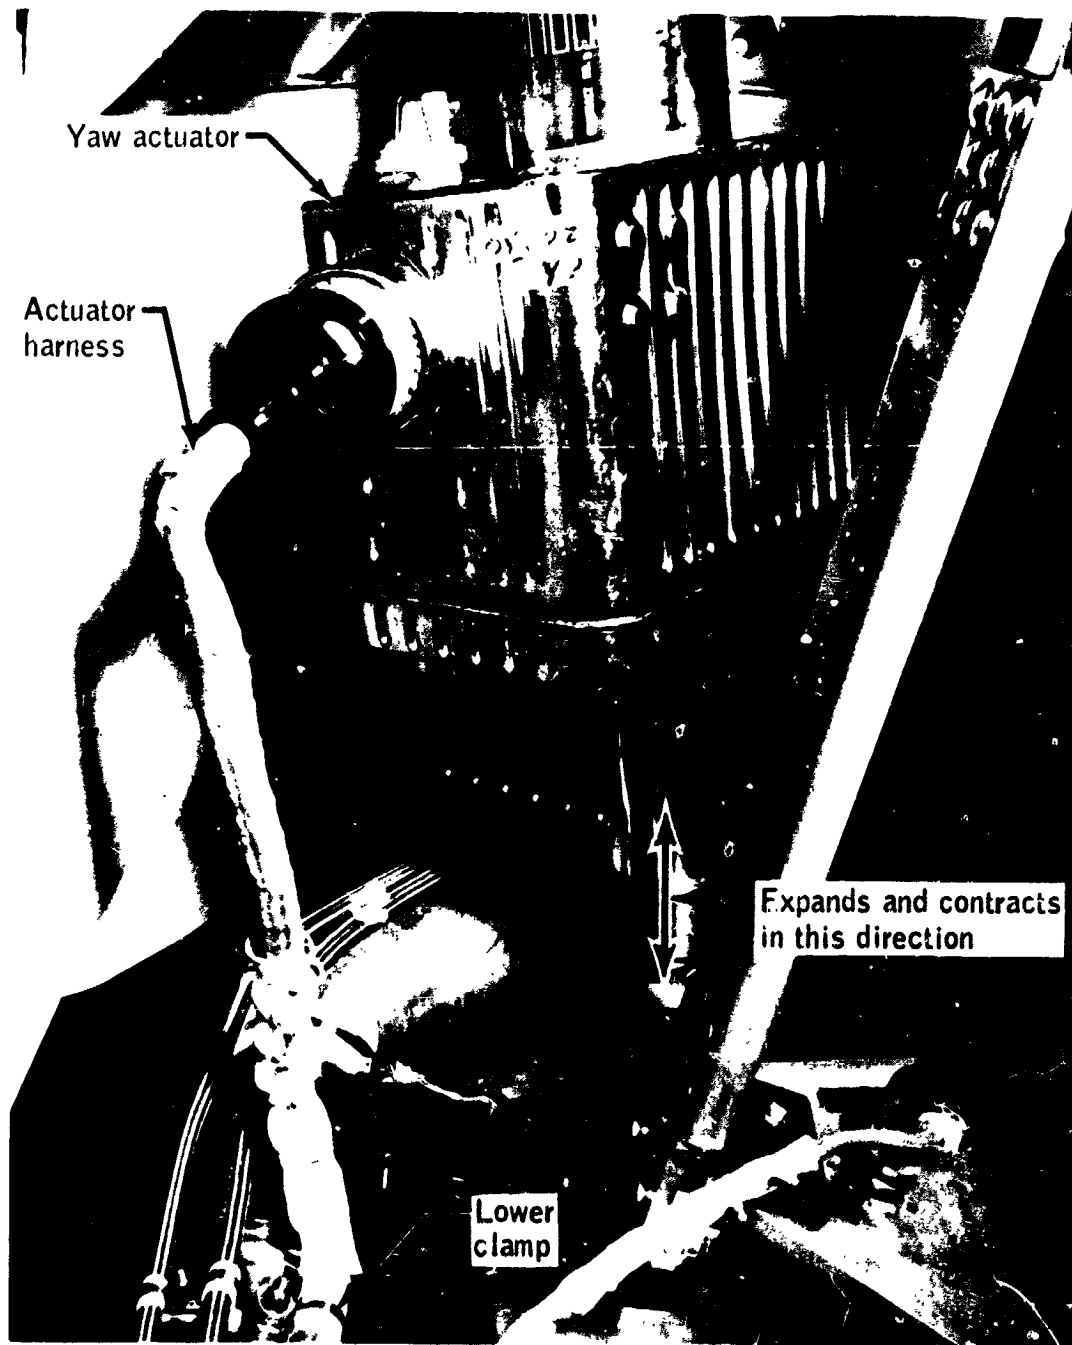
Figure 14-12.- Yaw actuator assembly and interconnecting wiring.

The cause of the failure was an open in the rate feedback loop of the secondary yaw servo system. Postflight testing of command module wiring and connectors and bench testing of the thrust vector servo assembly did not reveal any abnormalities. Therefore, the failure must have occurred in the service module wiring or connectors. Possible pin corrosion on the engine gimbal actuator wiring harness connectors or broken wires in the yaw gimbal wiring loop are the most probable causes of the flight problem. A broken wire would result from inadequate strain relief (see fig. 14-12) due to cable flexing. Wiring harnesses to the actuator assembly on three other vehicles were reviewed and found to move when the engine was gimballed. Motion of the actuator produced a strain on the harness at the lower clamp. The position of this clamp was changed for the remaining vehicles to provide strain relief.

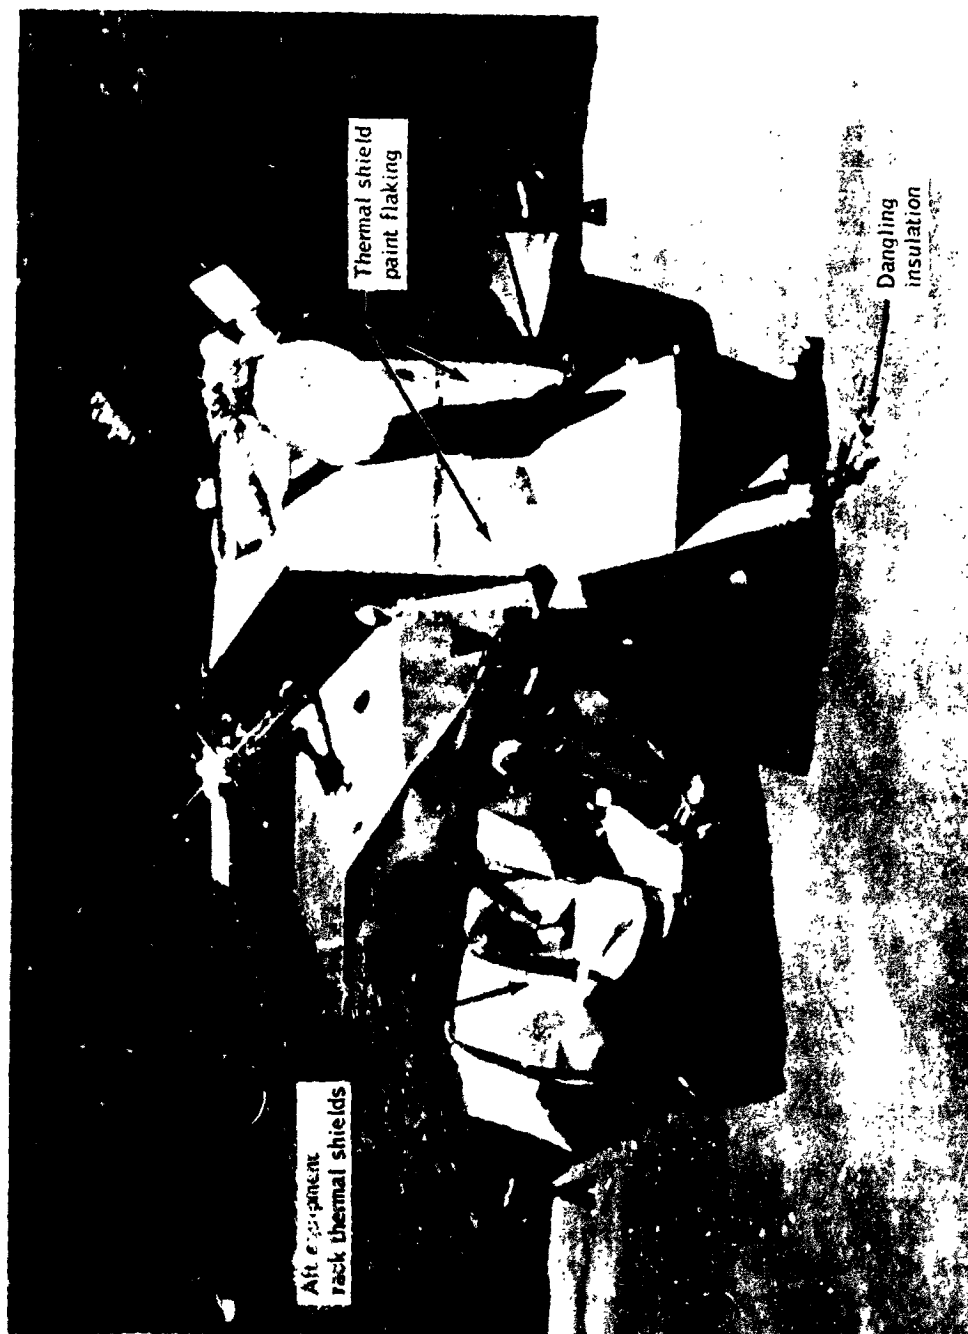
Figure 14-26.- Paint flaking and damaged thermal shield panels.

The most probable cause of the failure was ascent engine exhaust entering the cavity behind these thermal shields. A cross section of the lower edge of the shields is shown in figure 14-27. Analysis shows that the thermal shield which extends below the support tube allows a pressure buildup on the closure shield which exceeds its capability. Once the closure shield failed, the exhaust entered the cavity behind the shield, resulting in a pressure buildup exceeding the capability of the vertical thermal shields. The detailed flight configuration in this area was not tested.

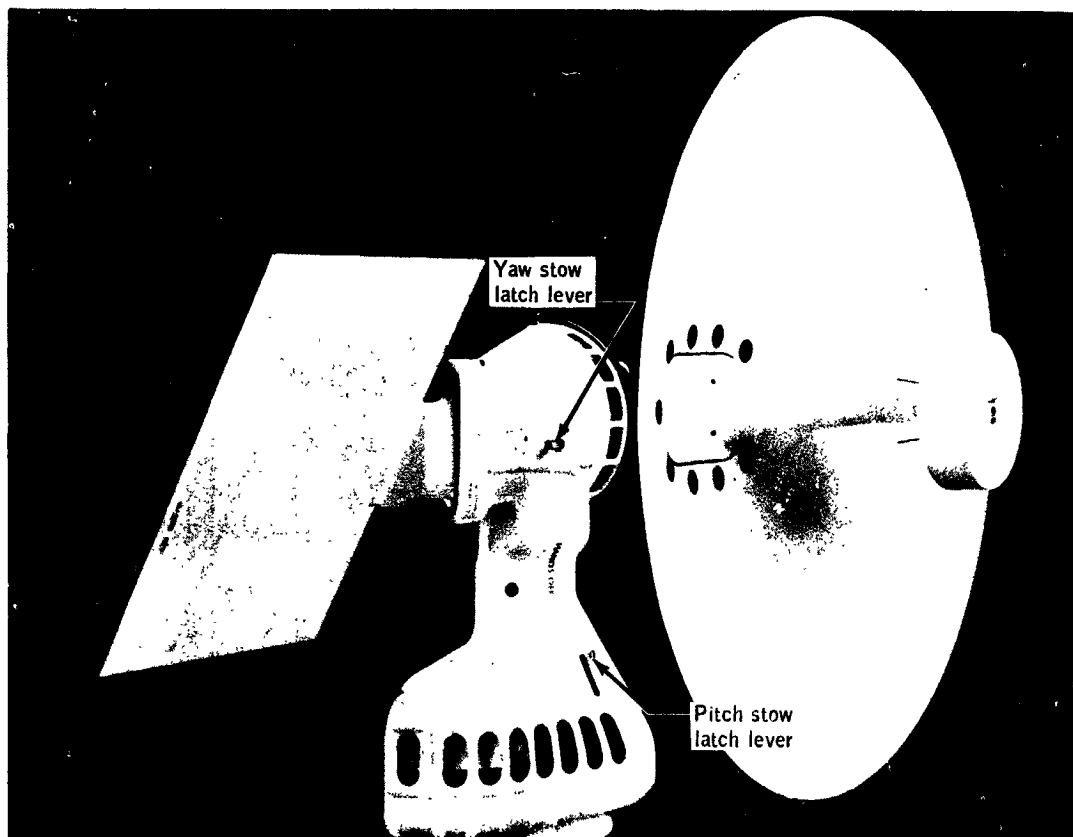
Figure 14-29.- Lunar module S-band steerable antenna.

The S-band steerable antenna (fig. 14-29) would not move in the yaw axis during initial activation. Several unsuccessful attempts were made to operate the unit using both the manual slew and auto track modes. Photographs and inflight test data show that the problem was caused by failure of the mechanical stow latch to release.

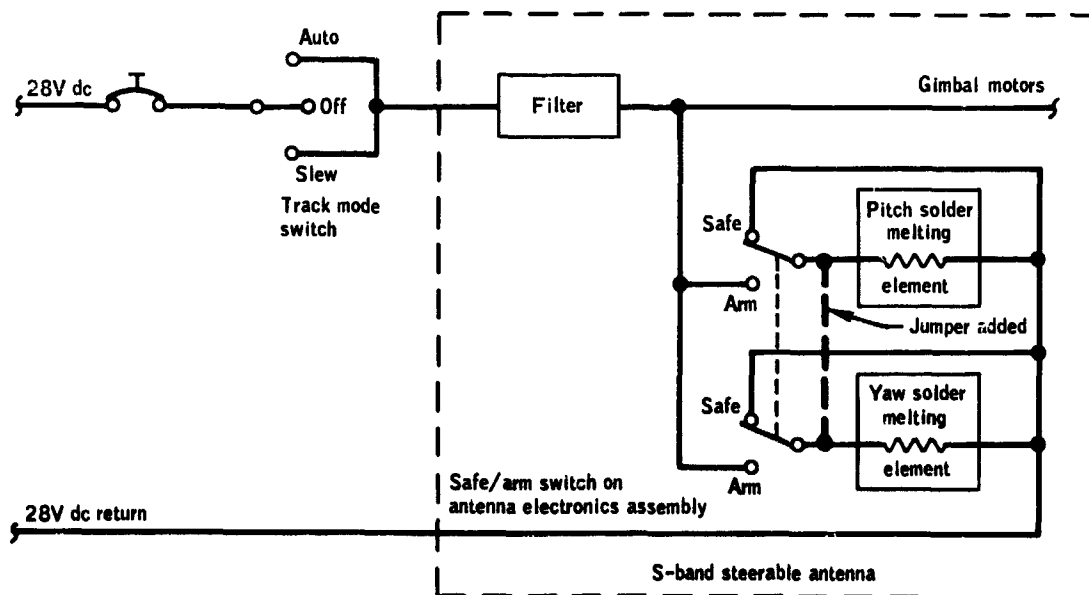
Figure 14-31.- Lunar module steerable antenna stow-latch circuit.

There are several areas in the electrical circuitry which could have caused the problem. One is that one contact in the safe/arm switch (figure 14-31) did not make. The second is that an open may have existed downstream of the safe/arm switch, either in the solder-melting element or in the wiring back through ground. A resistance measurement is made across the two parallel solder-melting elements prior to flight. About a 3-ohm increase in resistance was found at the last check. This change is equivalent to a possible 10-ohm increase in one of the elements which could have reduced the power dissipation below that required to melt the solder. Allowable tolerances on mechanical drawings and tests on sample latches have shown that it is possible for a solder fillet extending below the ring to make physical contact with the housing (fig. 14-30). The

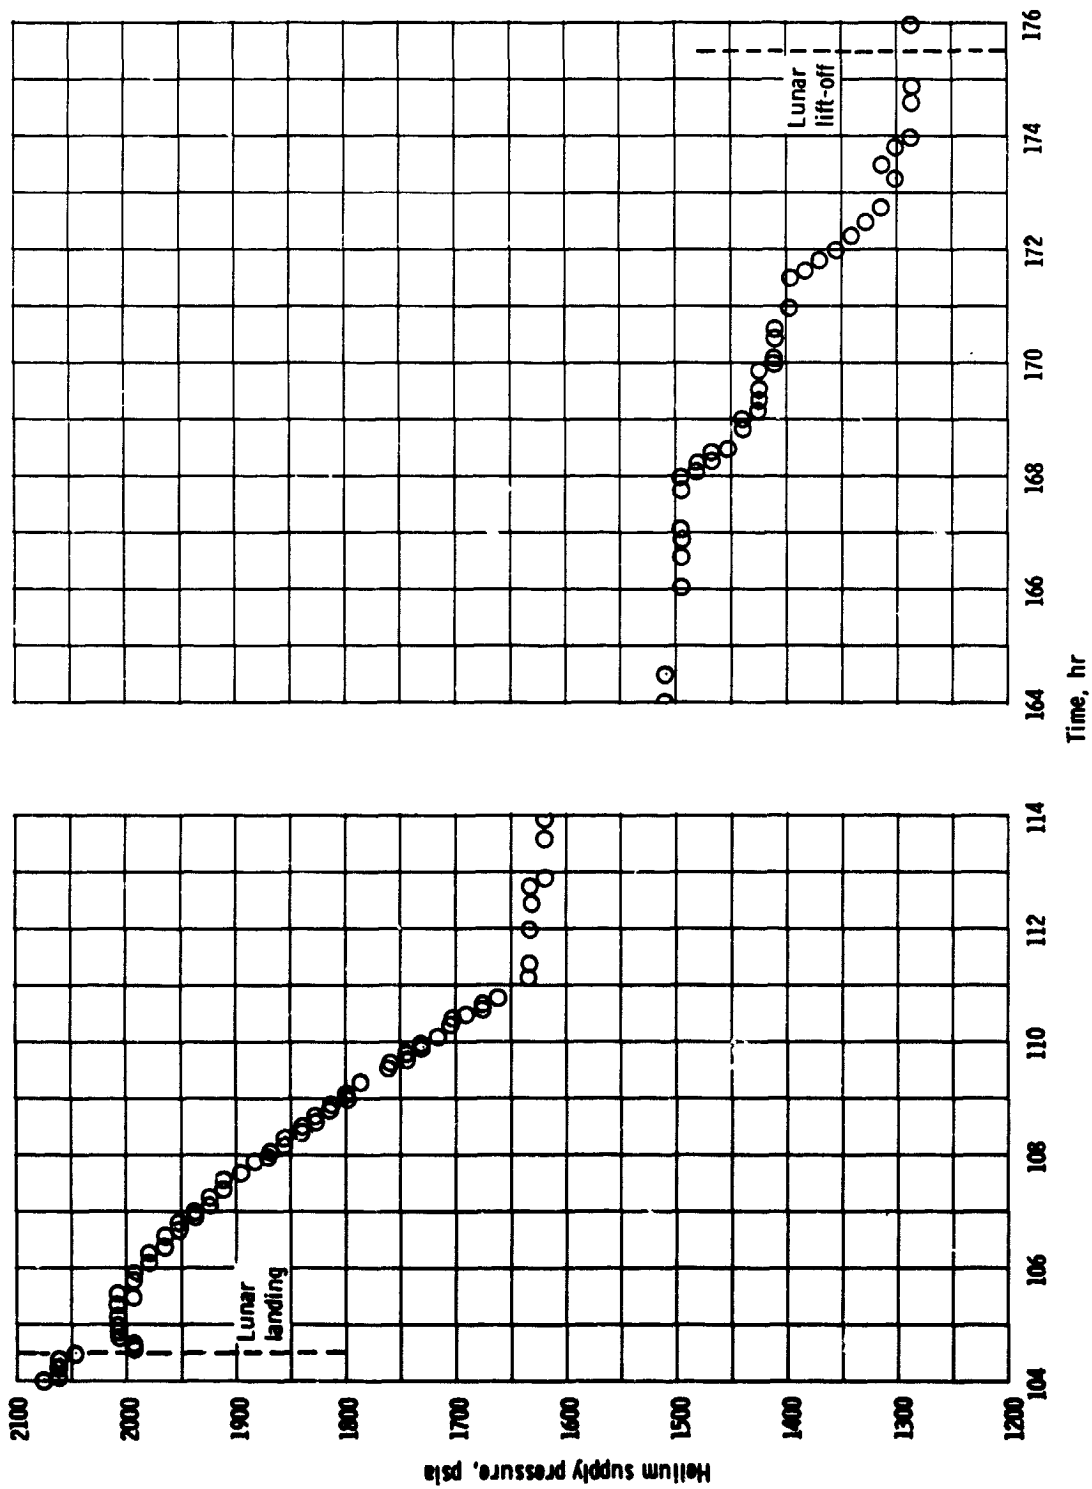
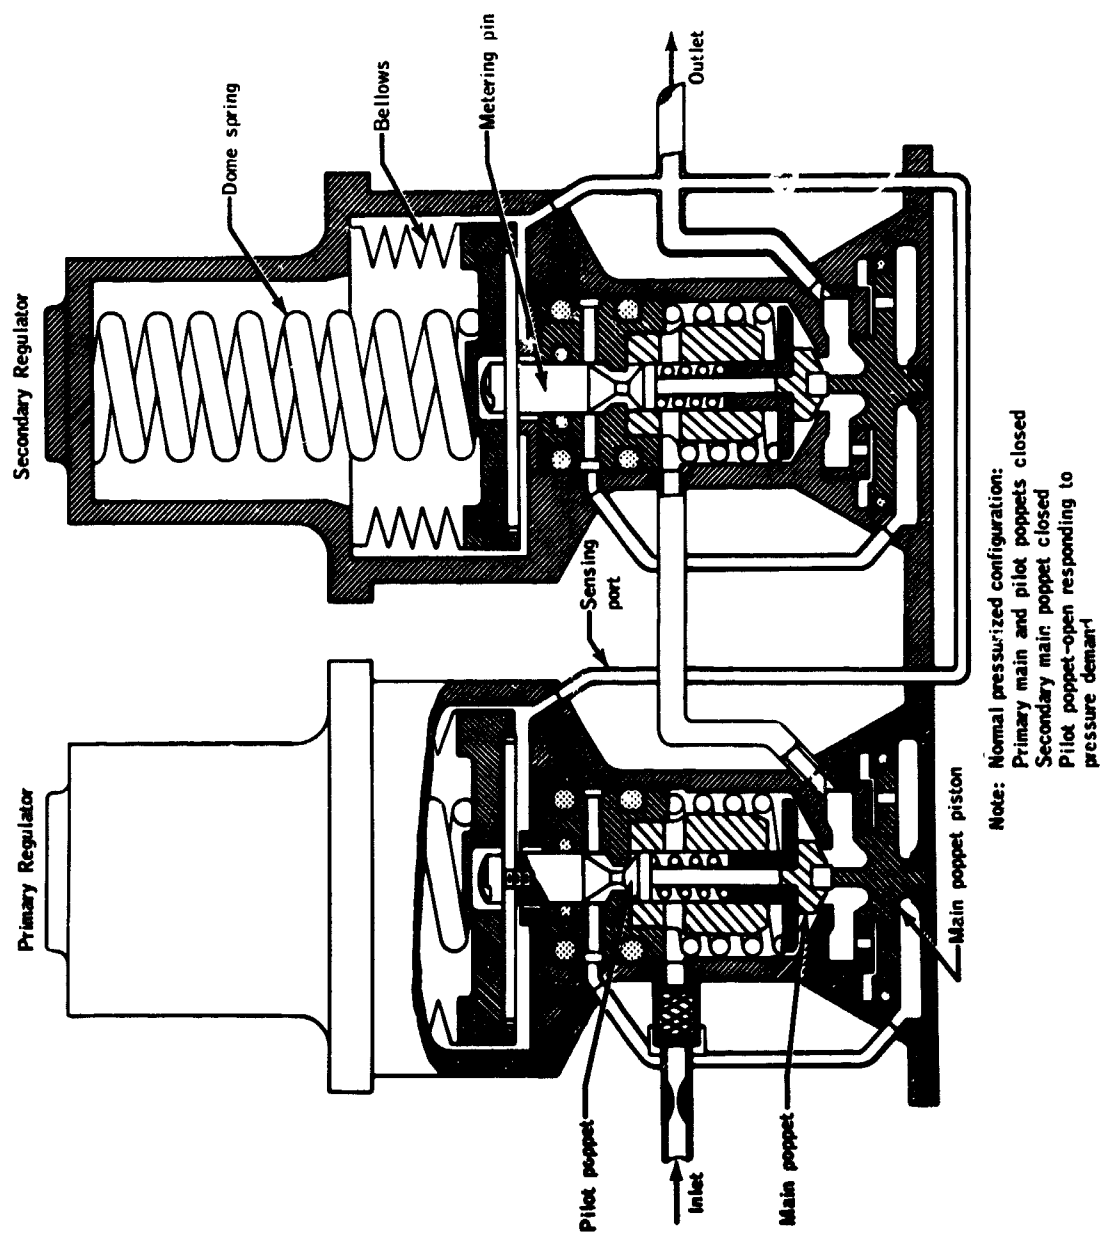
Figure 14-36.- Cross-section of reaction control regulator.

The helium regulator assembly consists of two series regulators (figure 14-36). The unit immediately exposed to the high pressure source is designated as the primary regulator and the downstream unit as the secondary regulator. Both units are identical in configuration with the exception of shims which are used to determine their pressure settings. The primary unit is set to regulate at 181 ± 3 psia; the secondary, at 185 ± 3 psia.

A series of tests was performed to determine lockup characteristics of nine spare regulators under small differential pressure conditions. The tests showed that a design deficiency in the secondary regulator does not exist, but did not eliminate the possibility of a weak poppet spring or sticky poppet in the Apollo 16 regulators since they were not tested under the same conditions. Further, the test demonstrated that the flight anomaly was the result of two discrepancies within the regulator assembly. A matrix of the possible leakage paths is shown in table 14-I. As can be seen from the matrix, there are 15 possible double-failure combinations which can result in the anomalous condition observed during the flight. Of these, the four involving only the poppets are considered probable since the leakage was variable. A variable leak path is usually caused by particulate contamination on a poppet seat. The particulate contamination could have been inside the regulator assembly during ground tests, but located in such a manner that it was not dislodged by the gas flow under 1-g conditions. In a weightless condition, the contamination could have moved and deposited between any of the poppets and their seats.
